Manhole Inspection Summary

Manhole # S47CC_012MH

Insp Date: **2/4/08 10:08 AM**

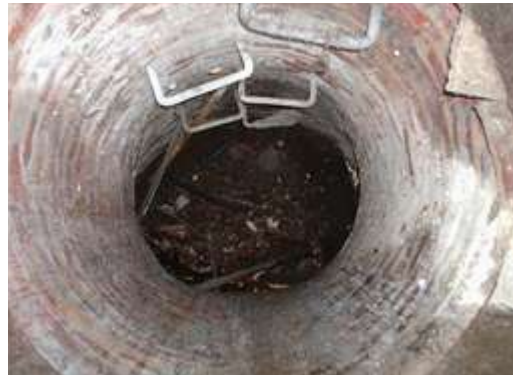
Top View

☒ **Leaks**

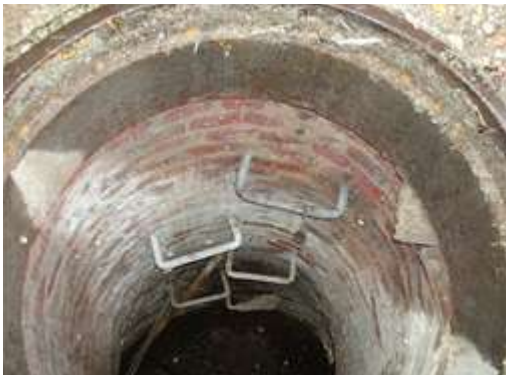
Defect 1

Loose Brick

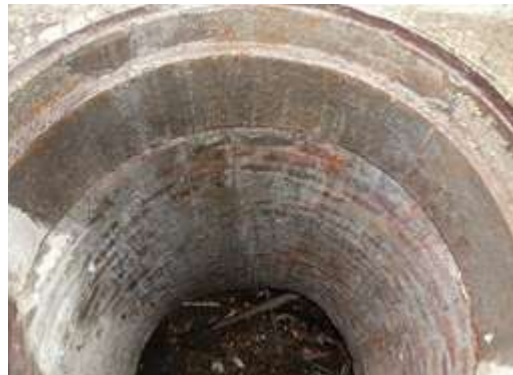
Defect 2

Infiltration: ☐ None ☐ Joint ☐ Cracks ☐ Mortar ☐ Roots ☒ **Wall**

Infiltration

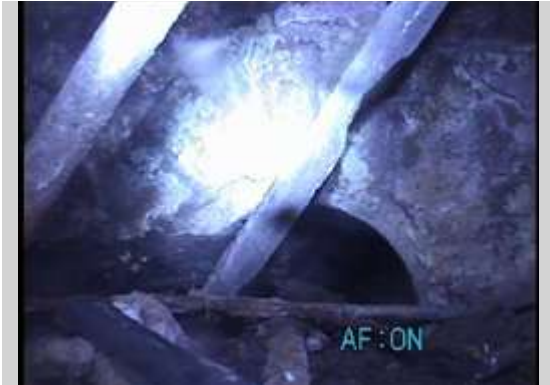
12 O'Clock Outflow

10 in. Circular Gravity Sewer
Pipe Out @ 12 O'Clock

Infiltration: **None** Pipe Seal Cond: **Sound**
